# Manhole Inspection Summary

Manhole # S13UU\_026MH

Insp Date: **5/11/07 1:31 PM**

**Location** Address: **3010 WABASH AVE**

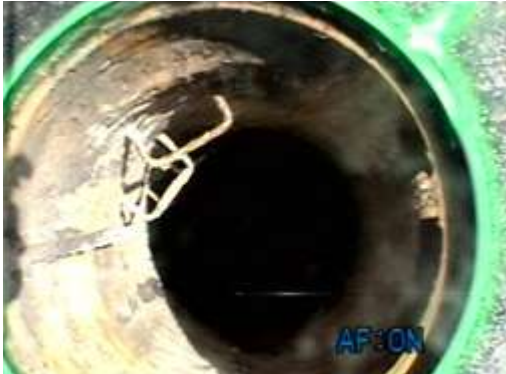
Defect 1

**Frame** Offset: **4** (in.) Condition: ☒ Sound ☐ Cracked ☐ Leaks

OFFSET FRAME

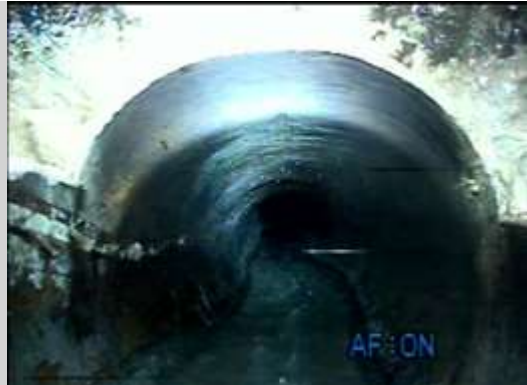
12 O'Clock Outflow

15 in. Circular Gravity Sewer  
Pipe Out @ 12 O'Clock

Pipe Material: **PVC** ☐ Pipe Lined

Invert Depth: **12.20** (ft.) Flow Characteristics: **Fast**

Deposits: ☒ None ☐ Mud ☐ Sludge ☐ Debris ☐ Grease

Infiltration: **None** Pipe Seal Cond: **Sound**

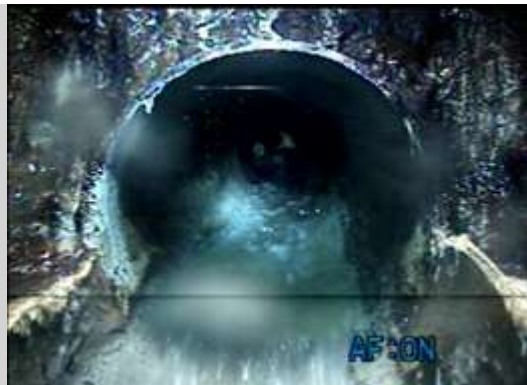
6 O'Clock Inflow

15 in. Circular Gravity Sewer  
Pipe In @ 6 O'Clock

Pipe Material: **PVC** ☐ Pipe Lined

Invert Depth: **11.55** (ft.) Flow Characteristics: **Fast**

Deposits: ☒ None ☐ Mud ☐ Sludge ☐ Debris ☐ Grease

Infiltration: **None** Pipe Seal Cond: **Sound**
